TMS320F2807x Real-Time MCUs Silicon Errata

Silicon Revisions C, B

This document describes the known exceptions to the functional specifications (advisories). This document may also contain usage notes. Usage notes describe situations where the device's behavior may not match presumed or documented behavior. This may include behaviors that affect device performance or functional correctness.

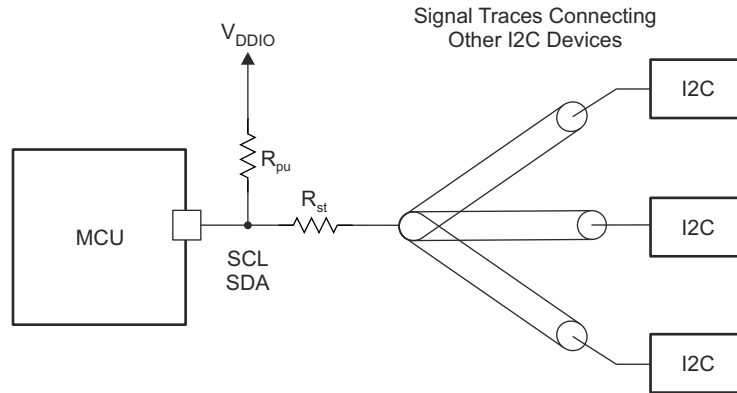
Figure 3-4. Placement of Series Termination Resistor and Pullup Resistor

The SDA and SCL outputs are implemented with push-pull 3-state output buffers rather than open-drain output buffers as required by I2C. While it is possible for the push-pull 3-state output buffers to behave as open-drain outputs, an internal timing skew issue causes the outputs to drive a logic-high for a duration of 0–5 ns before the outputs are disabled. The unexpected high-level pulse will only occur when the SCL or SDA outputs transition from a driven low state to a high-impedance state and there is sufficient internal timing skew on the respective I2C output.

This short high-level pulse injects energy in the I2C signals traces, which causes the I2C signals to sustain a period of ringing as a result of multiple transmission line reflections. This ringing should not cause an issue on the SDA signal because it only occurs at times when SDA is expected to be changing logic levels and the ringing will have time to damp before data is latched by the receiving device. The ringing may have enough amplitude to cross the SCL input buffer switching threshold several times during the first few nanoseconds of this ringing period, which may cause clock glitches. This ringing should not cause a problem if the amplitude is damped within the first 50 ns because I2C devices are required to filter their SCL inputs to remove clock glitches. Therefore, it is important to design the PCB signal traces to limit the duration of the ringing to less than 50 ns. One possible solution is to insert series termination resistors near the SCL and SDA terminals to attenuate transmission line reflections.

This issue may also cause the SDA output to be in contention with the slave SDA output for the duration of the unexpected high-level pulse when the slave begins its ACK cycle. This occurs because the slave may already be driving SDA low before the unexpected high-level pulse occurs. The glitch that occurs on SDA as a result of this short period of contention does not cause any I2C protocol issue but the peak current applies unwanted stress to both I2C devices and potentially increases power supply noise. Therefore, a series termination resistor located near the respective SDA terminal is required to limit the current during the short period of contention.

A similar contention problem can occur on SCL when connected to I2C slave devices that support clock stretching. This occurs because the slave is driving SCL low before the unexpected high-level pulse occurs. The glitch that occurs on SCL as a result of this short period of contention does not cause any I2C protocol issue because I2C devices are required to apply a glitch filter to their SCL inputs. However, the peak current applies unwanted stress to both I2C devices and potentially increases power supply noise. Therefore, a series termination resistor located near the respective SCL terminal is required to limit the current during the short period of contention.

Insert series termination resistors on the SCL and SDA signals and locate them near the SCL and SDA terminals. The SCL and SDA pullup resistors should also be located near the SCL and SDA terminals. The placement of the series termination resistor and pullup resistor should be connected as shown in [Figure 3-4](#).

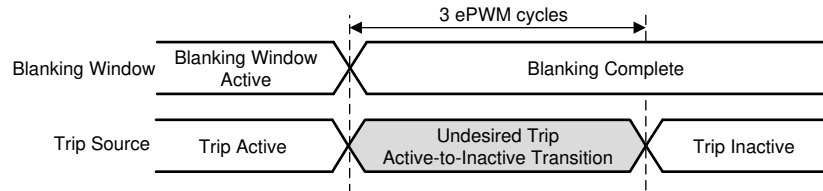
Figure 3-5. Undesired Trip Event and Blanking Window Expiration

Details The blanking window is typically used to mask any PWM trip events during transitions which would be false trips to the system. If an ePWM trip event remains active for less than three ePWM clocks after the end of the blanking window cycles, there can be an undesired glitch at the ePWM output.

Figure 3-5 illustrates the time period which could result in an undesired ePWM output.

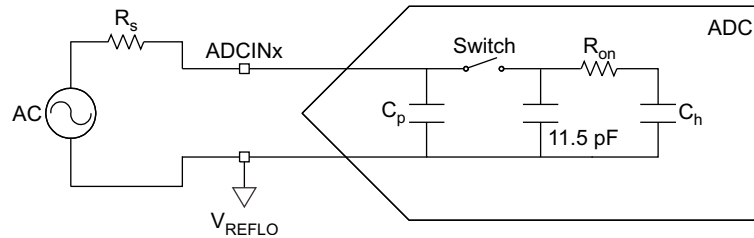
Figure 4-1. Single-Ended Input Model
Workarounds

The ADC input model should be used to select the sample-and-hold (S+H) duration for each ADC input. For the revisions affected, if the currently converting channel is an even-numbered channel and the previously converted channel was an odd-numbered channel (or vice versa), then the 12-bit input model will not accurately predict ADC input performance. Under these conditions, an additional capacitance should be added to the model. This capacitance has a value of 11.5 pF and should be placed between the S+H switch and R_{on} as shown in Figure 4-1.

For the revisions affected, when subsequent conversions switch between channel groups, the S+H duration should be chosen to account for the additional capacitance.
