Errata
MSP430F4152 Microcontroller

This document describes the known exceptions to the functional specifications (advisories).

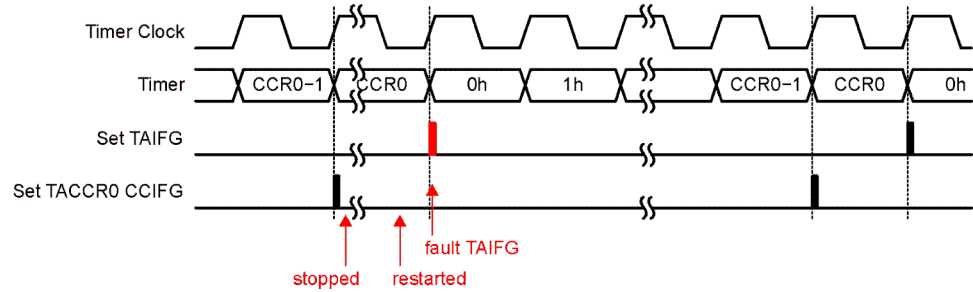
Workaround	None
TA18	TA Module
Category	Functional
Function	MOV to TACTL may clear TAR
Description	When TACTL is modified with a MOV instruction, the contents of TAR may be cleared, even when TACLR is not set.
Workaround	Use BIS or BIC instructions to modify TACTL.
Note	
A DMA transfer must not occur while these BIS and BIC instructions execute. This can be prevented by disabling the DMA prior to these instructions, or by using the DMAONFETCH bit to align DMA transfers to instruction fetch boundaries.	
TA21	TA Module
Category	Functional
Function	TAIFG Flag is erroneously set after Timer A restarts in Up Mode
Description	In Up Mode, the TAIFG flag should only be set when the timer counts from TACCR0 to zero. However, if the Timer A is stopped at TAR = TACCR0, then cleared (TAR=0) by

setting the TACLK bit, and finally restarted in Up Mode, the next rising edge of the TACLK will erroneously set the TAIFG flag.

Workaround None.
