MPC5200B (M62C) Errata

by: Microcontroller Division

This document identifies implementation differences between the MPC5200B, M62C (Rev. 1), and the processor's description contained in the *MPC5200B User's Guide* and the *MPC5200B Microcontroller Data Sheet*. Refer to <http://www.freescale.com> for the latest updates.

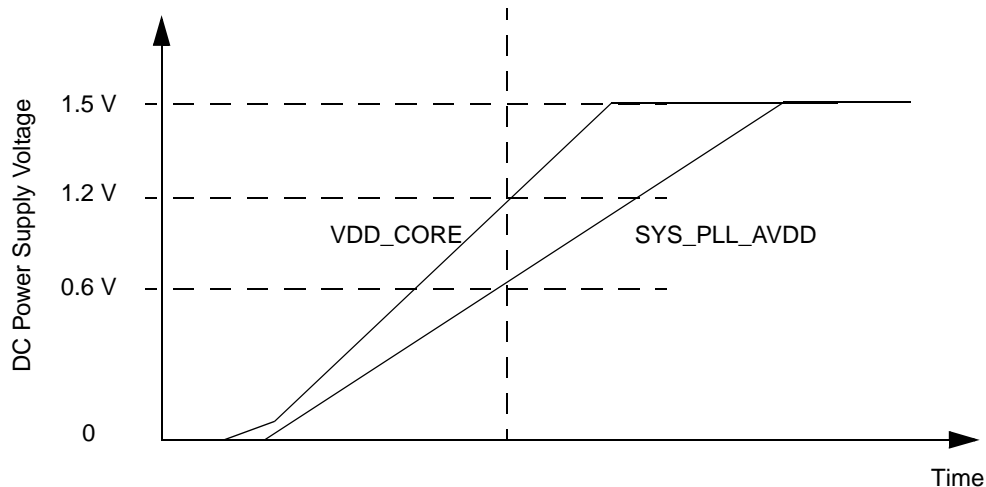
The system PLL can fail to start properly if the power supply pins on the MPC5200B are not properly sequenced. In particular, if the SYS_PLL_AVDD pin rises too early with respect to VDD_CORE, the system PLL can drive the VCO to oscillate at a frequency beyond the capability of the PLL to respond. The overall result is that the internal bus clocks run too fast and the device fails to fetch instructions.

A filter/delay circuit must be implemented so that SYS_PLL_AVDD is delayed with respect to VDD_CORE. Specifically, VDD_CORE must reach a value of 1.2 volts before SYS_PLL_AVDD reaches 0.6 volts.
